AEROSPACE REPORT NO.
TR-0089(4935-08)-1

An Investigation of the Effect of Low Velocity Impacts on P75/934 Graphite/Epoxy Composites

J. N. SCHURR, M. T. QUINN, and G. F. HAWKINS
Materials Sciences Laboratory
Laboratory Operations

1 April 1991

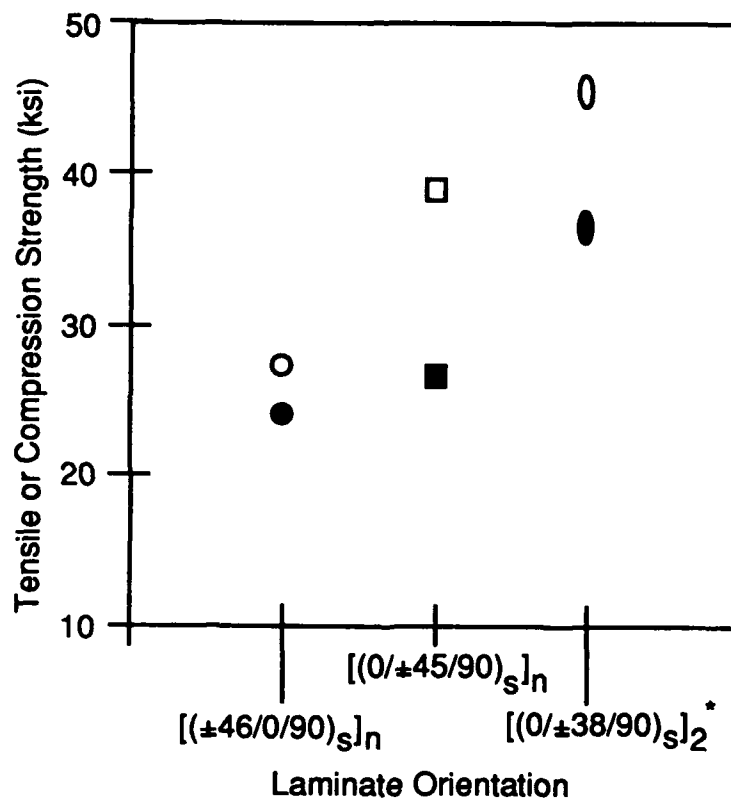
Fig. 5. Average Tensile (open symbols) and Compression (filled symbols) Strength Data for Various P75/934 Laminate Composites.

tested at Delsen Laboratories appear to have failed near the center of the specimen; the test values, 45 and 36 ksi, should therefore be a fair indication of actual tensile and compression strengths for these laminates. Note, however, that NDT-1 essentially had a $[(0/+38/-38/90)_s]_2$ lay-up, except that one of the 38° plies was replaced with a 52° ply.

Other researchers (Ref. 6) measured average ultimate tension and compression strength values of 39.5 and 26.4 ksi, respectively, for a $[(0/+45/-45/90)_s]_n$ P75S/934 laminate. These strength values are lower than those of NDT-1, as would be expected of a laminate with fibers oriented further from the 0° test axis. Figure 5 is a plot of all available mechanical strength data for the various P75/934 laminate orientations.

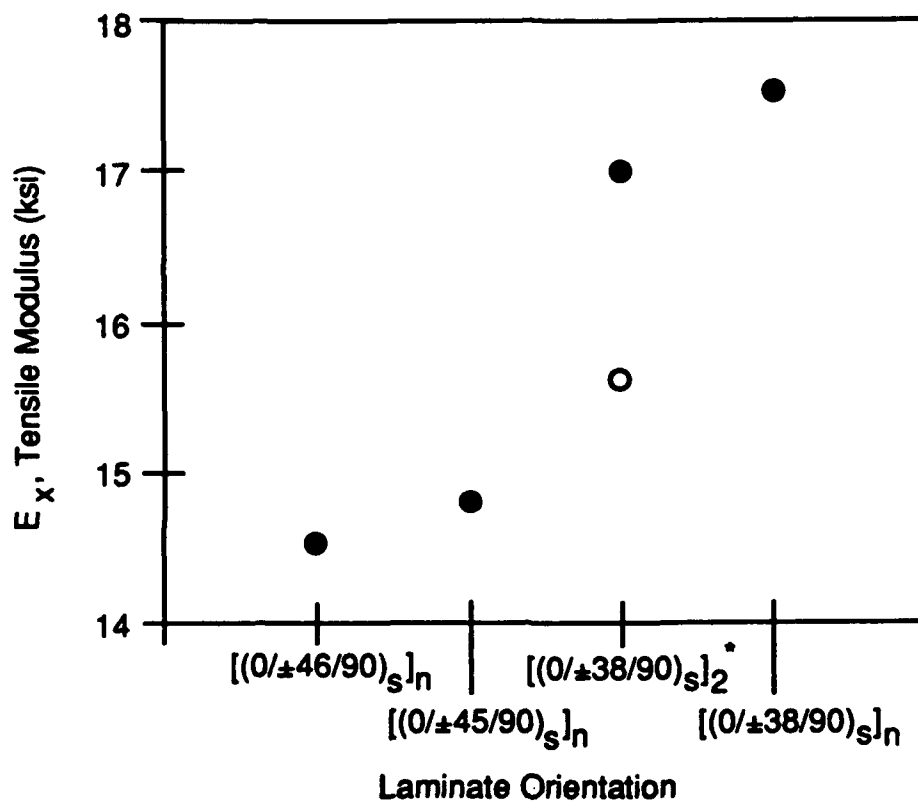
Fig. 6. Calculated Longitudinal Tensile Modulus (filled circles) vs Laminate Orientation for Ultrahigh Modulus Type Composites. Measured longitudinal tensile modulus (open circle) for the P75/934 NDT-1 specimen.

The effect of ply lay-up on the variation of longitudinal tensile modulus, E_x , is illustrated in Fig. 6 for several laminate orientations. The moduli were computed assuming the following monoply properties: longitudinal modulus, $E_x = 42$ ksi; transverse modulus, $E_y = 1.5$ ksi; shear modulus, $G_{xy} = 0.5$ ksi; and Poisson's ratio, $\nu = 0.3$ (typical values for ultrahigh modulus graphite/epoxy unidirectional prepreg tape). The longitudinal modulus increases as the $\pm \theta$ angle fibers approach the 0° direction, i.e., $[(0/\pm 38/90)_s]_n$ has a higher modulus than $[0/\pm 45/90)_s]_n$, which has a higher modulus than $[(0/\pm 46/90)_s]_n$. In addition, when one 38° ply is replaced with a 52° ply in $[0/\pm 38/90)_s]_2$, as in the case of NDT-1, the tensile modulus is lowered. The NDT-1 specimen modulus value, also included in Fig. 6, was found to be less than the computed value. Actual monoply moduli and Poisson's ratio values may not have matched those assumed in the computed laminate modulus.

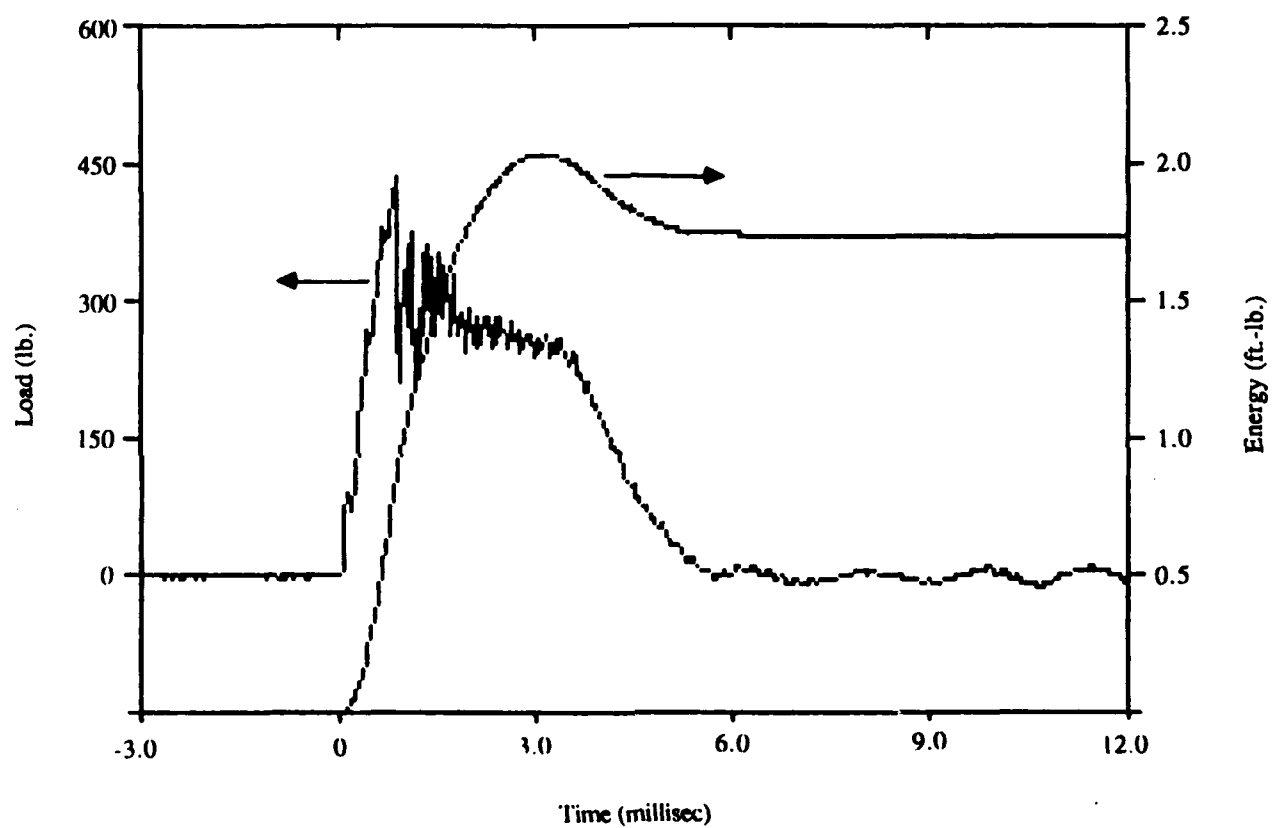
Fig. 9. Plot of Load and Energy vs Time for NDT-4.11

The measured load and calculated absorbed energy vs time plot for NDT-4.11 is shown in Fig. 9. When the impactor first hits the specimen, the load rises linearly as the specimen undergoes elastic deformation. Then there may be yield behavior with increased damage to the impacted plate. The load continues to rise to a maximum, at which point the load drops suddenly, indicating brittle failure.

The energy corresponding to the point at which the load curve first dips or changes slope (incipient load) is normally referred to as the incipient energy (Ref. 15). The incipient energy value measures the absorbed energy required to initiate damage, as indicated on the load curve by the

reduction in specimen stiffness. The incipient load is not always obvious on the load curves. The load signal may have extraneous fluctuations because of the dynamic interactions between the specimen and the impactor, or the change in slope may be very subtle. To simplify matters, for NDT-4.10, -4.11, -6.10, and -6.11, we considered the incipient load to be the same as the maximum load. Table 4 reveals that for three of the four samples of comparable thickness, the incipient energy was approximately 10 in.-lb. NDT-4.10, the through-penetration specimen, had a lower value of about 6 in.-lb.

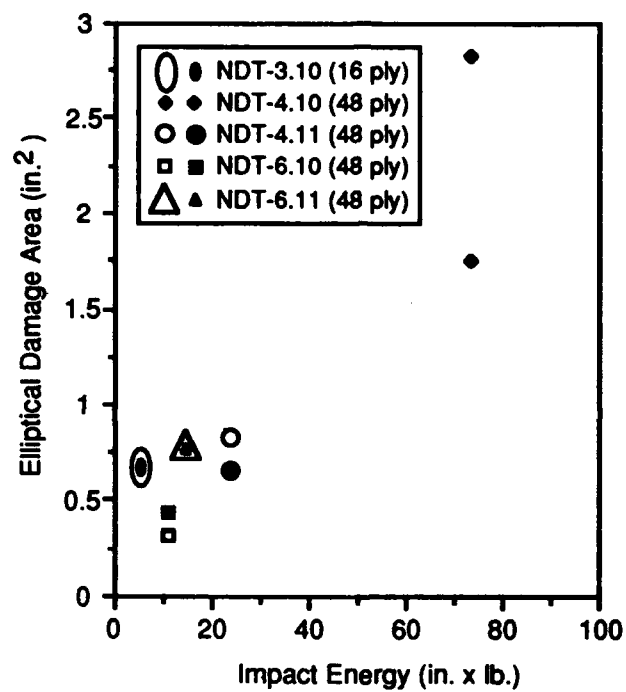
Fig. 12. Elliptical Damage Area Determined from X-ray Radiographs of Dye Enhanced Specimens (open symbols) and C-Scan Data (closed symbols) vs Impact Energy for the NDT Specimens

The dye-enhanced specimens were X rayed again at 30 kV/30 mA for 1 to 2 min. On the radiographs, the damaged areas appear white. The size and shape of the impact damaged area were clearly highlighted (see Fig. 11-- print of radiograph). In Figs. 12 and 13, an elliptical damage area is plotted vs energy of impact for the NDT and LONG specimens, respectively. The damage area was calculated using the maximum damage length measured from the radiographs in the 0° and 90° direction. An elliptical damage shape was assumed for the calculation. Greater damage areas were found for specimens with higher energies of impact.

The NDT elliptical damage size measurements from the C-scan data vs impact energy is included in Fig. 12 for comparison with the X-ray data of dye-enhanced specimens. The C-scan damage size followed closely with the X-ray results for all NDT specimens except NDT-4.10. When NDT-4.10 was impact tested, the impactor completely penetrated the specimen and several plies were lifted off the surface of the laminate. While the through-transmission ultrasonic evaluation revealed the internal delamination type

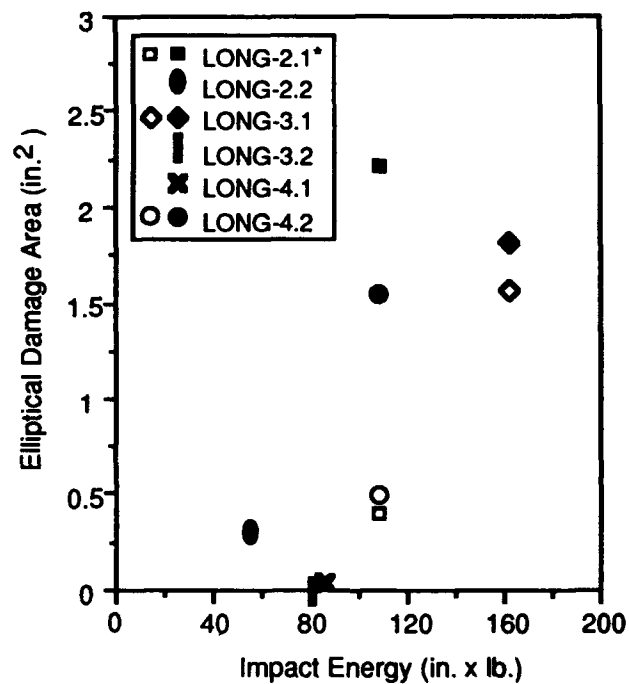
Fig. 13. Elliptical Damage Area Determined from X-ray Radiographs of Dye Enhanced Specimens (open symbols) and C-Scan Data (closed symbols) vs Impact Energy for the LONG Specimens.

*Note: LONG-2.1 was impacted twice. The second impact was nominally 27 in.-lb.

Ultrasonic C-scan results for the LONG specimens indicated that no significant damage existed before impact testing. Post-impact C-scan damage measurements are plotted vs impact energy in Fig. 13. The most extensive damage occurred in LONG-2.1, but this was the specimen that was inadvertently impacted twice. In comparison with the damage area determined by X-ray radiography, the C-scan results indicate a much larger damage area (see LONG-2.1 and -4.2 in Fig. 13). These differences probably occurred because it was difficult to penetrate these LONG specimens adequately with the radiopaque dye. The crack opening in both these two LONG specimens was tight, and the specimens themselves were much thicker than the NDT specimens. When a LONG specimen was impacted with sufficient energy to produce large cracks, as in LONG-3.1, the damage area detected by the dye-enhanced X-ray method was comparable to that of the ultrasonic method.

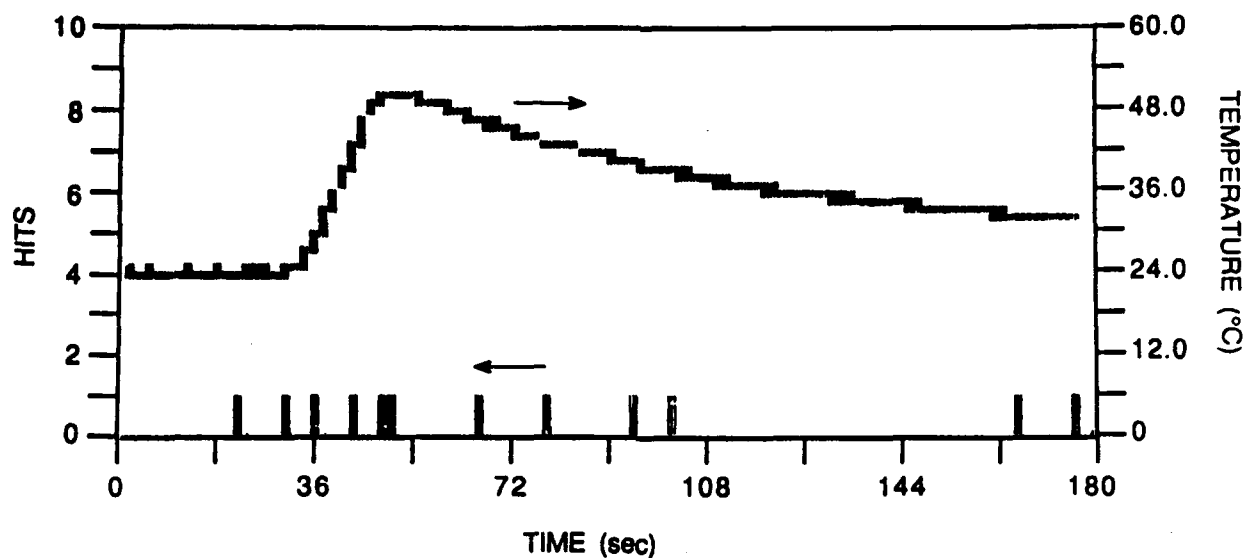
Fig. 18. Acoustic Emission from an Undamaged Specimen

The first run was made on an undamaged specimen cut from NDT-4. The results are graphed in Fig. 18. As expected, no notable AE was detected from the undamaged specimen. When a damaged specimen was tested, AE increased with increased temperature. In their work with carbon-carbon composites, G. F Hawkins et al. attributed the increase in AE signal to the increase in thermal strain caused by the larger thermal gradient (Ref. 16). The results from NDT-4.11 are shown in Fig. 19. The AE data from the four specimens tested indicate an inverse relationship between number of events and impact energy. Also, the amplitude of each event increased with increasing impact energy.
